**DEPARTMENT OF TRANSPORTATION****DIVISION OF ENGINEERING SERVICES**

Quality Assurance and Source Inspection

Contract #: 04-0120F4Cty: SF/ALA Rte: 80 PM: 13.2/13.9File #: 82.28**WELDING INSPECTION REPORT****Resident Engineer:**Siegenthaler, Peter**Address:** 333 Burma Road**City:** Oakland, CA 94607**Report No:** WIR-017681**Date Inspected:** 26-Oct-2010**Project Name:** SAS Superstructure**OSM Arrival Time:** 700**Prime Contractor:** American Bridge/Fluor Enterprises, a JV**OSM Departure Time:** 1530**Contractor:** Westmont Industries**Location:** Santa Fe Springs, CA.**CWI Name:** R. Rodriguez, R. Dominguez**CWI Present:** Yes No**Inspected CWI report:** Yes No N/A**Rod Oven in Use:** Yes No N/A**Electrode to specification:** Yes No N/A**Weld Procedures Followed:** Yes No N/A**Qualified Welders:** Yes No N/A**Verified Joint Fit-up:** Yes No N/A**Approved Drawings:** Yes No N/A**Approved WPS:** Yes No N/A**Delayed / Cancelled:** Yes No N/A**Bridge No:** 34-0006**Component:** Travelers**Summary of Items Observed:**

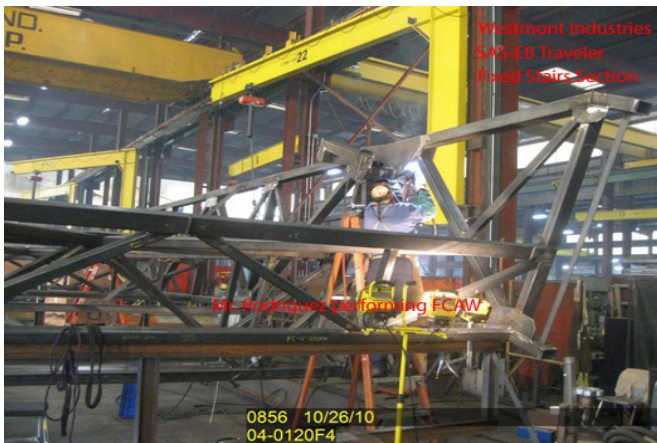
On this date, the QA Inspector observed Westmont Industries (WMI), production welder, Mr. Jose Rodriguez (WID # 3031), continuing to perform Flux Core Arc Welding (FCAW) activities on the previously fit Frame assemblies, identified as 10-A237, 11-B237, 3-A217, 4-A218, 5-A223 and 6-A224. The QA Inspector observed throughout the shift, that the FCAW was being performed in various positions, on the connector plate and Tube Steel (TS) material. The QA Inspector observed that approximately half way through the shift, that a WMI production helper appeared to be performing grinding activities on the completed fillet and flare groove welds. The QA Inspector observed that the grinding was being performed on areas of the welds, which appeared to be excessive reinforcement and removal of weld spatter.

See attached picture below.

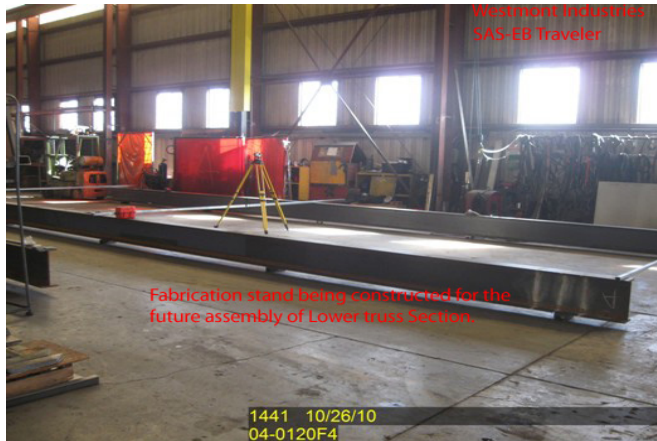
The QA Inspector observed that WMI Production Supervisor Juan Mora was nearby and Mr. Mora explained that this area of Bay 4 is currently being cleared of material, so that the area can be utilized for the fabrication of the SAS-EB, Lower Truss Section Assembly. Later in the shift, the QA Inspector observed that the area had been cleared of material and the above mentioned personnel were in process of erecting a fabrication stand, consisting of Wide Flange Beam (WFB) and channel material.

See attached picture below.
